**AN 18 YEAR PERFORMANCE STUDY OF THE
STAYFLEX™ CORROSION CONTROL
AND THERMAL INSULATION SYSTEM
MANUFACTURED BY
PREFERRED SOLUTIONS, INC.
CLEVELAND, OHIO**

**PERFORMANCE SURVEY PERFORMED BY
WORLD INTERNATIONAL TESTING, INC.
STEUBENVILLE, OHIO**

***SURVEY DATE:
FEBRUARY 27, 2002***

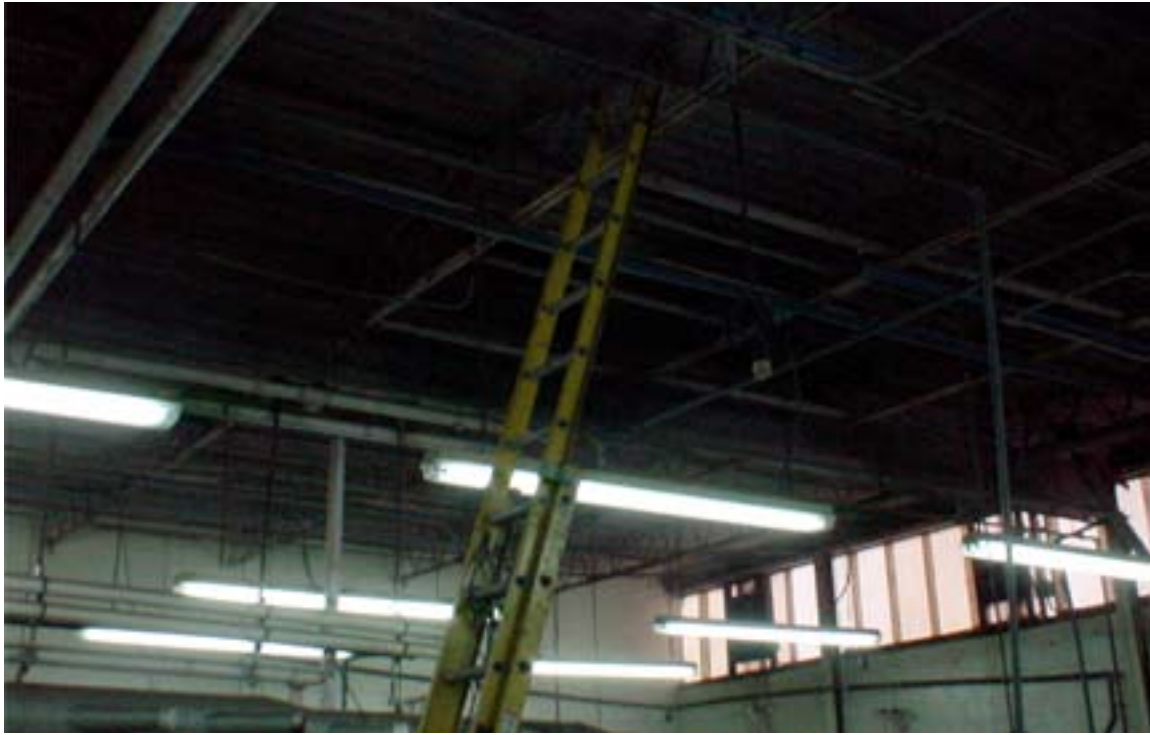
ILLUSTRATION 1: GENERAL VIEW OF TEST SITE SELECTED FOR EVALUATION OF STAYFLEX™ SYSTEM AFTER 18 YEARS OF SERVICE.

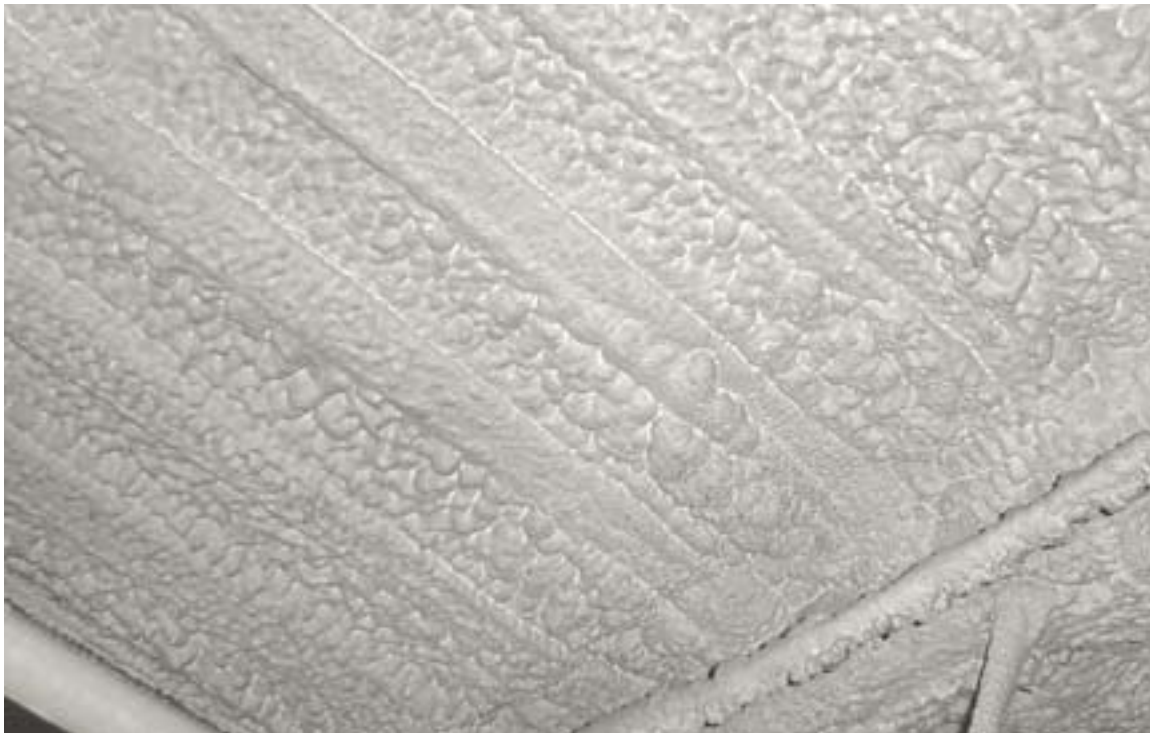
ILLUSTRATION 2: GENERAL VIEW OF STAYFLEX™ SYSTEM IN SERVICE IN A HIGH ACID VAPOR ENVIRONMENT AFTER 18 YEARS. NO EVIDENCE OF DELAMINATION OR SAGGING DISCOVERED.

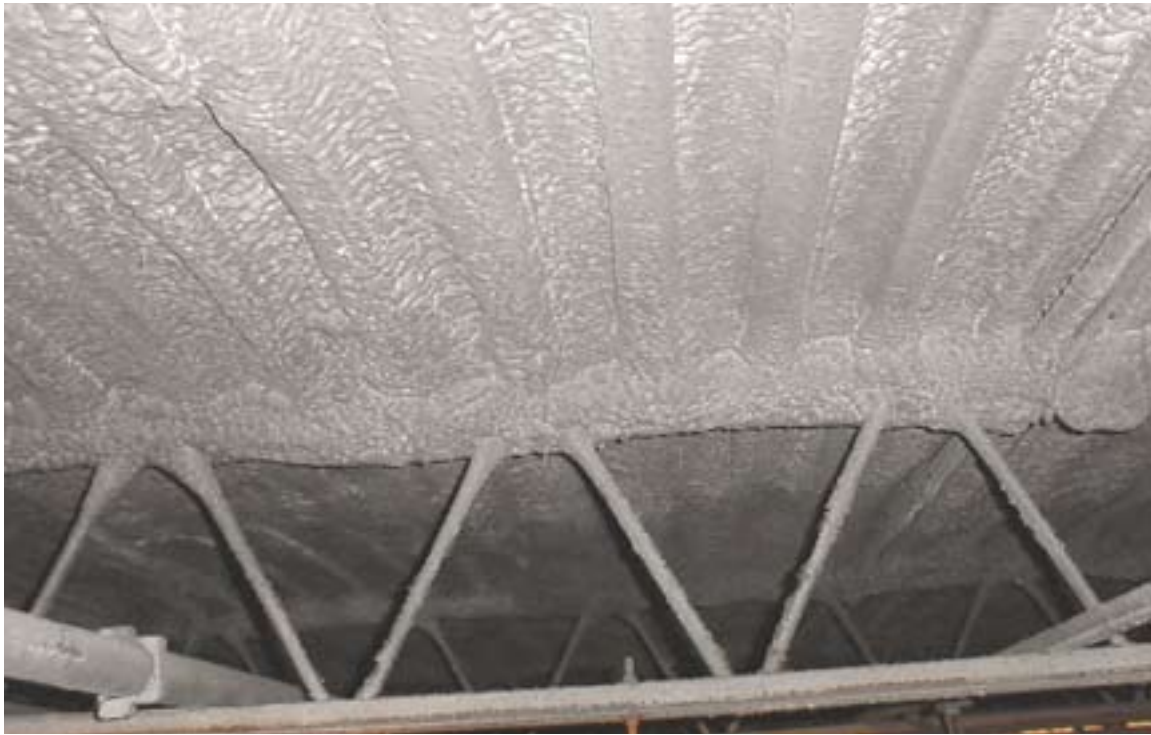
ILLUSTRATION 3: VIEW OF TEST REGION SELECTED, LOCATED IN PROXIMITY TO HYDROCHLORIC ACID PROCESS.

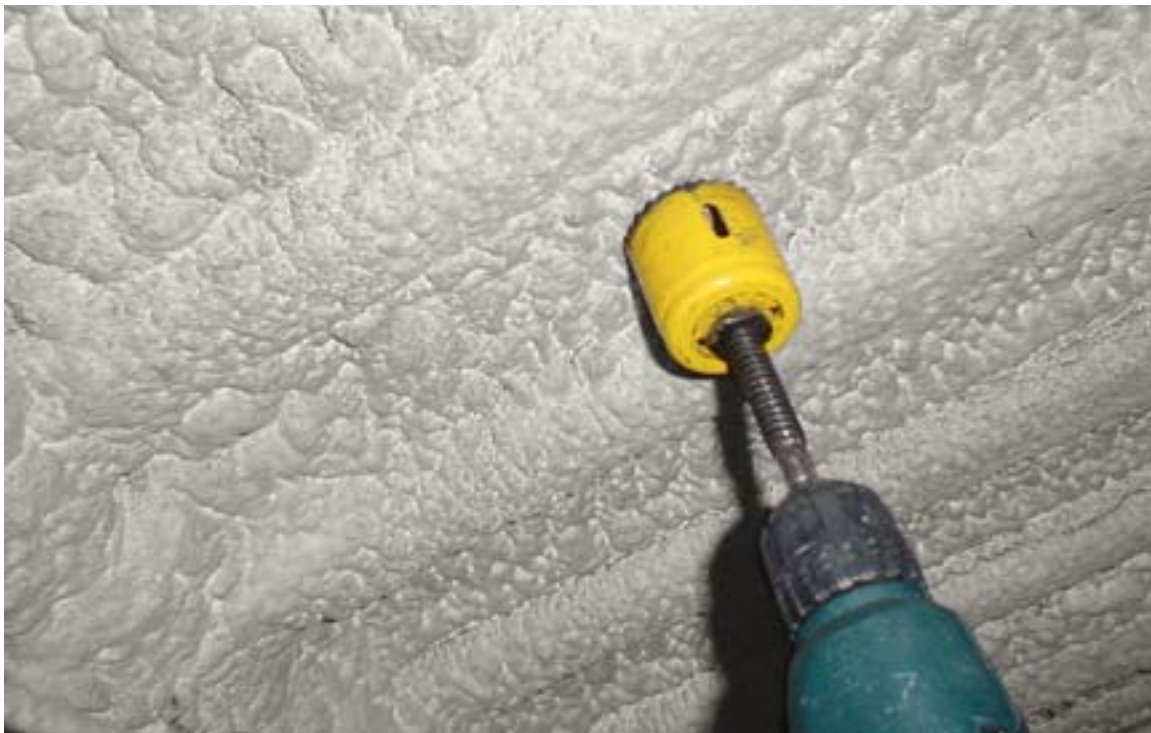
ILLUSTRATION 4: VIEW OF CORE SAMPLING EXTRACTION FOR SUBSURFACE EVALUATION.

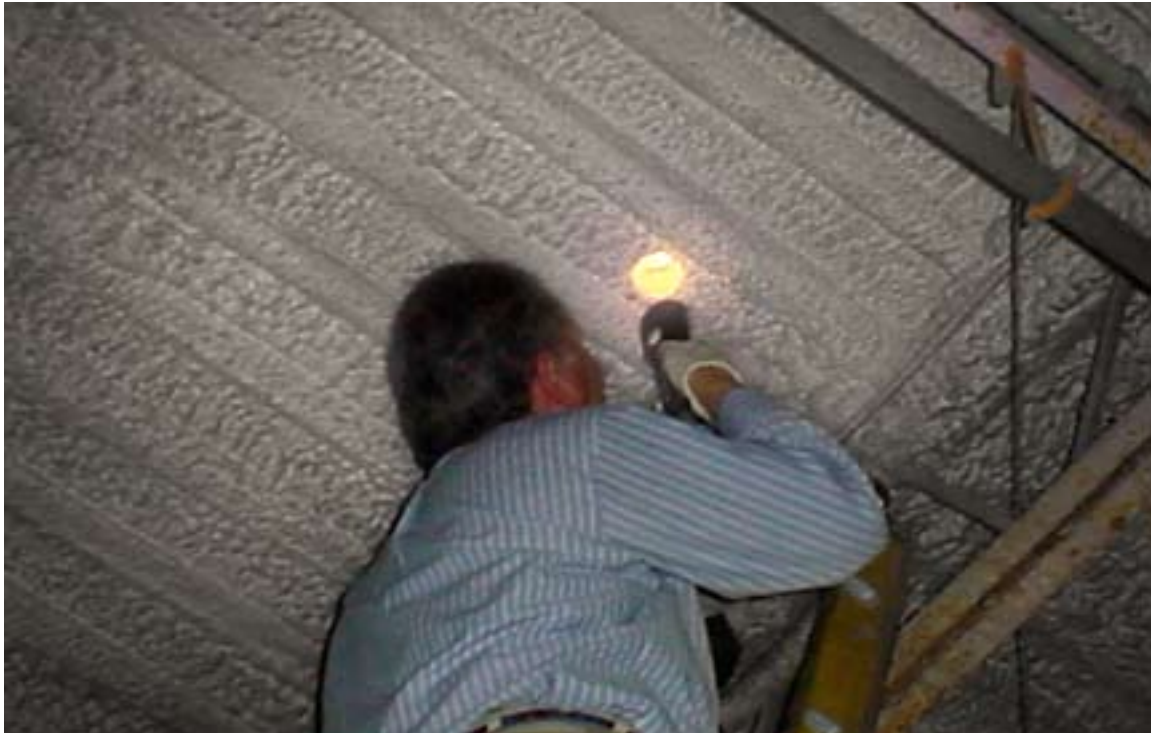
ILLUSTRATION 5: VIEW OF SUBSURFACE SUBSTRATE CONDITION SURVEY.

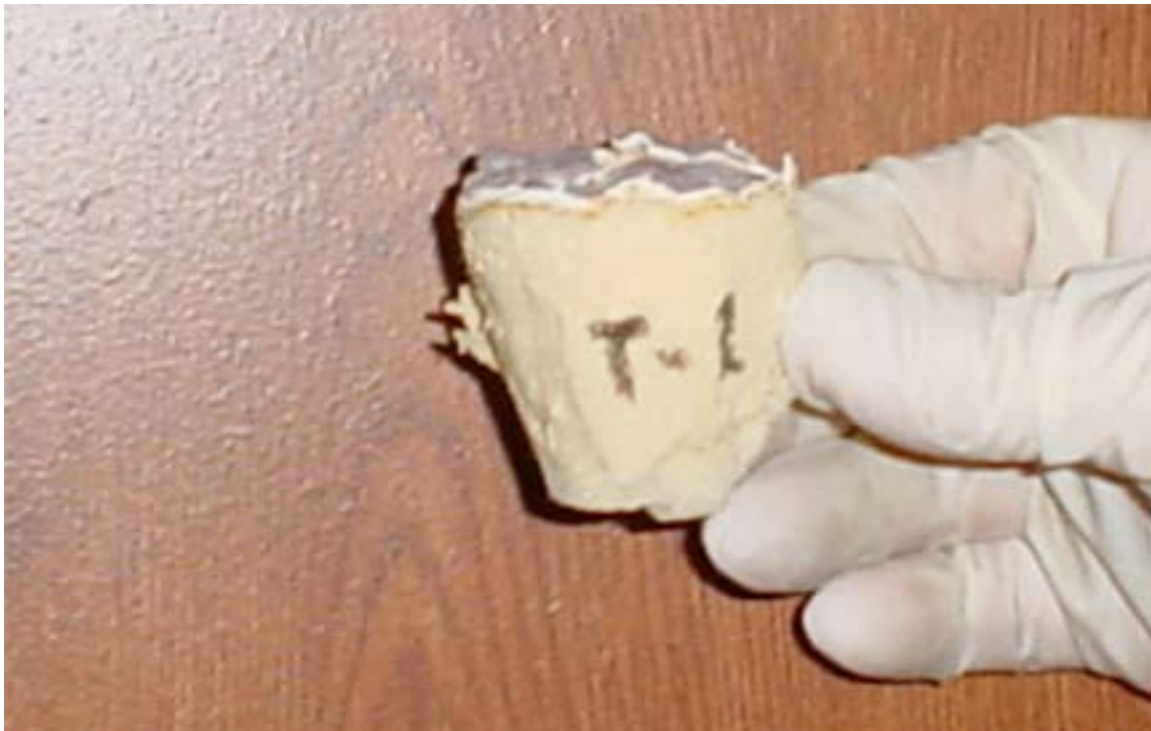
3. Illustrations 2-16 show specific test locations, along with extraction activity. As you can see in Illustration 6, 10 and 12, the core sample conditions were favorable. Over the eighteen-year service life, virtually no degradation of the rigid polyurethane foam insulation was detected. Cross-section views of the hard shell, vinyl-ester polymer fire-resistant coating indicated a positive integrity, with no indication of composite system degradation or delamination. The topcoat did experience discoloration and slight contaminant permeation. However, this should be considered minor in relationship to the prolonged aggressive exposure over an eighteen-year period.

ILLUSTRATION 6: CROSS SECTION VIEW OF TEST CORE SAMPLE 1.
THERE WAS NO VISIBLE MATERIAL DEGRADATION NOTED.

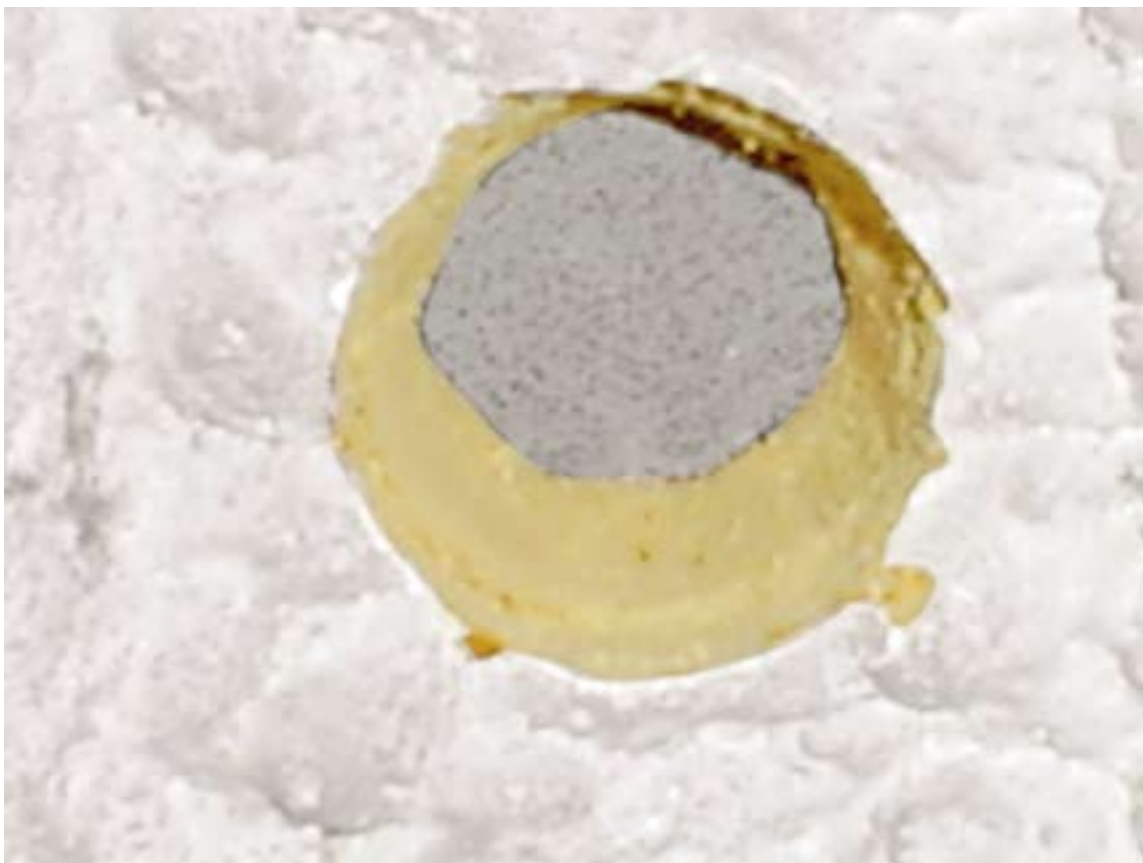
ILLUSTRATION 7: VIEW OF TEST REGION 1 , STEEL DECKING SUBSTRATE CONDITIONS. THE PINPOINT CORROSION CELLS THAT WERE OBSERVED DURING THE 1994 EVALUATION HAVE INCREASED SLIGHTLY. THIS WOULD INDICATE THAT THE STAYFLEX™ SYSTEM IS PROVIDING EXCELLENT PROTECTION FOR THE STEEL IN A HIGHLY ACIDIC ENVIRONMENT.

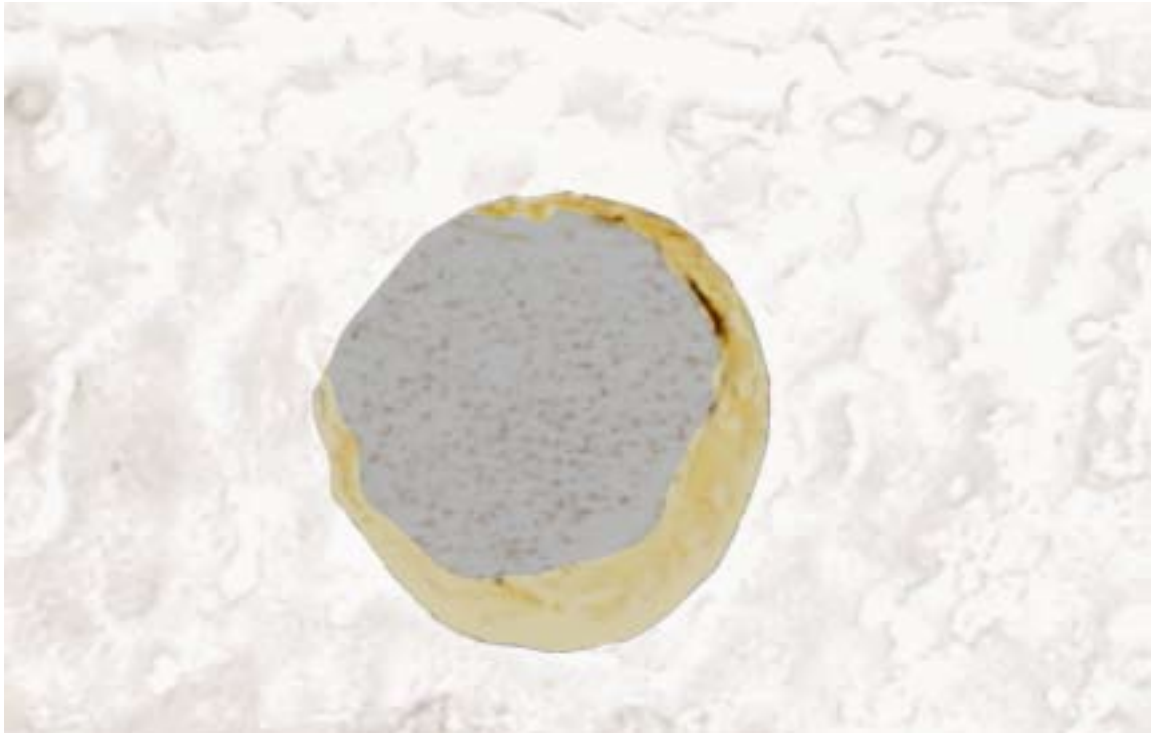
ILLUSTRATION 8: VIEW OF CORE SAMPLE 2 COATING AND SUBSTRATE CONDITIONS. AS IN SAMPLE 1, PINPOINT CORROSION WAS OBSERVED. IN COMPARISON TO THE UNPROTECTED ROOF DECKING SEEN IN ILLUSTRATION 15, THE LIFE EXPECTANCY PROJECTIONS FOR THE ROOF CAN BE ESTIMATED IN EXCESS OF AN ADDITIONAL 25 YEARS.

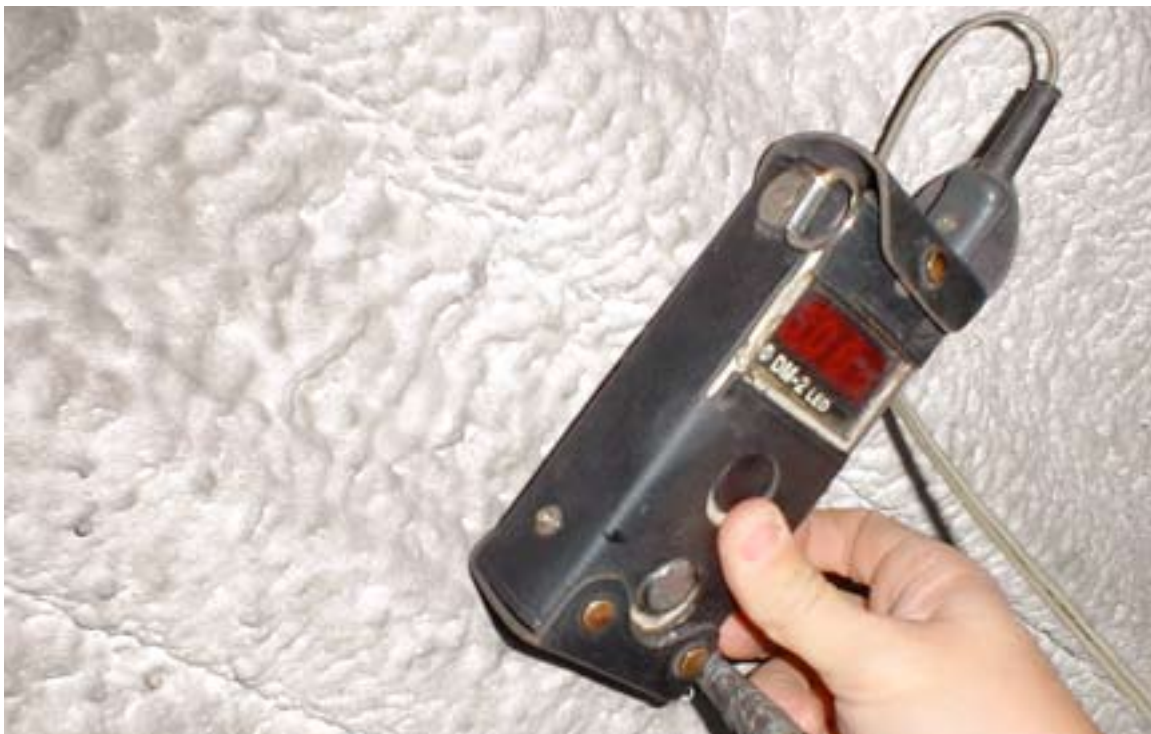
ILLUSTRATION 9: ULTRASONIC TESTING OF THE STEEL VERIFIED THAT NO MEASURABLE SECTION LOSS HAS OCCURRED.

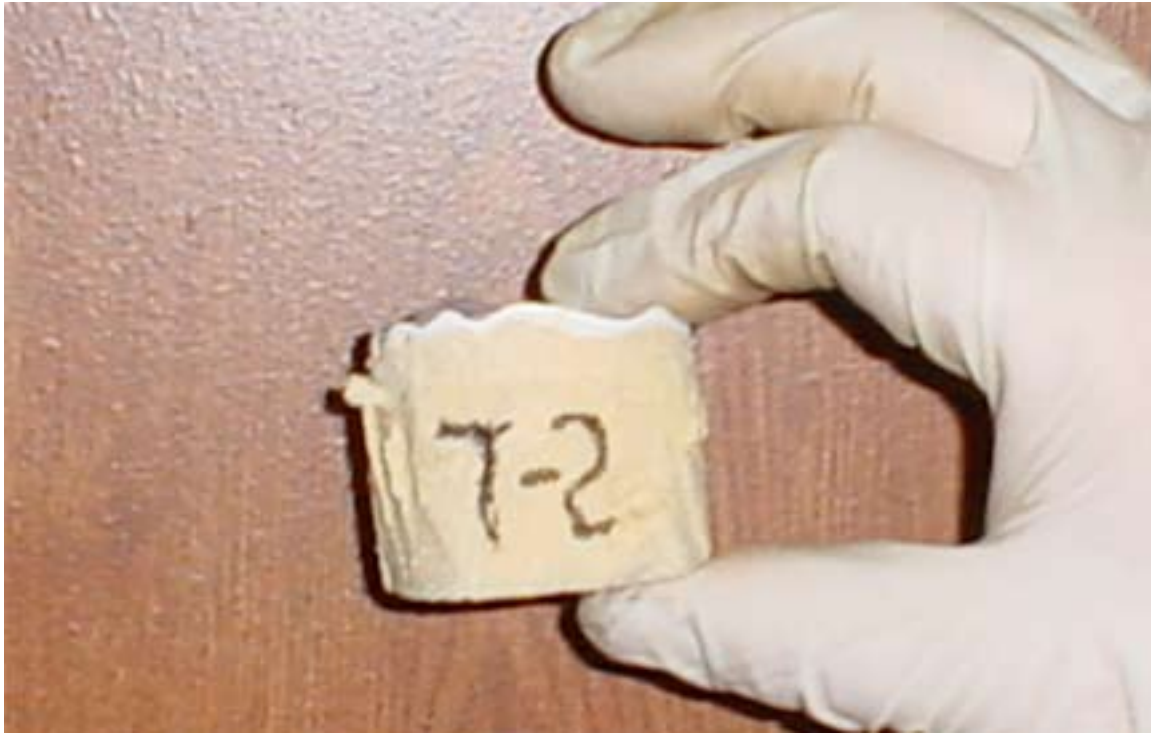
ILLUSTRATION 10: CROSS SECTION VIEW OF TEST CORE SAMPLE 2.
THERE IS NO VISIBLE MATERIAL DEGRADATION NOTED.

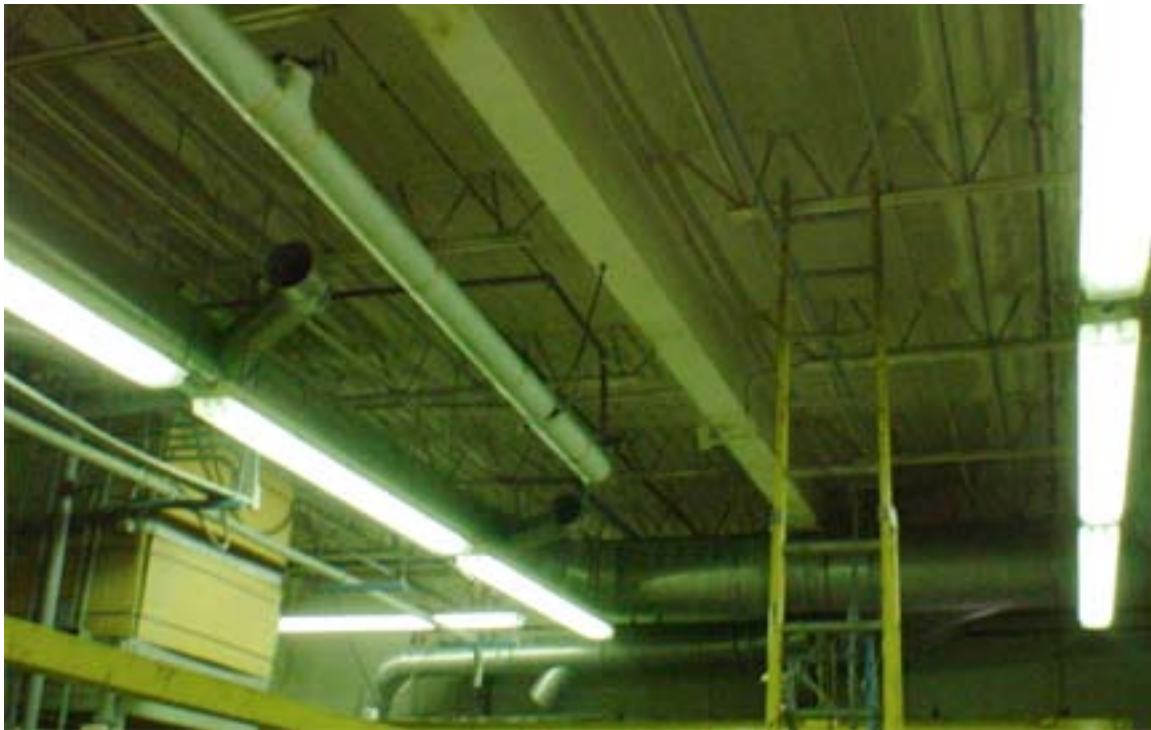
ILLUSTRATION 11: VIEW OF SECOND TEST SITE SELECTED FOR
EVALUATION OF STAYFLEX™ SYSTEM AFTER 18 YEARS OF SERVICE.

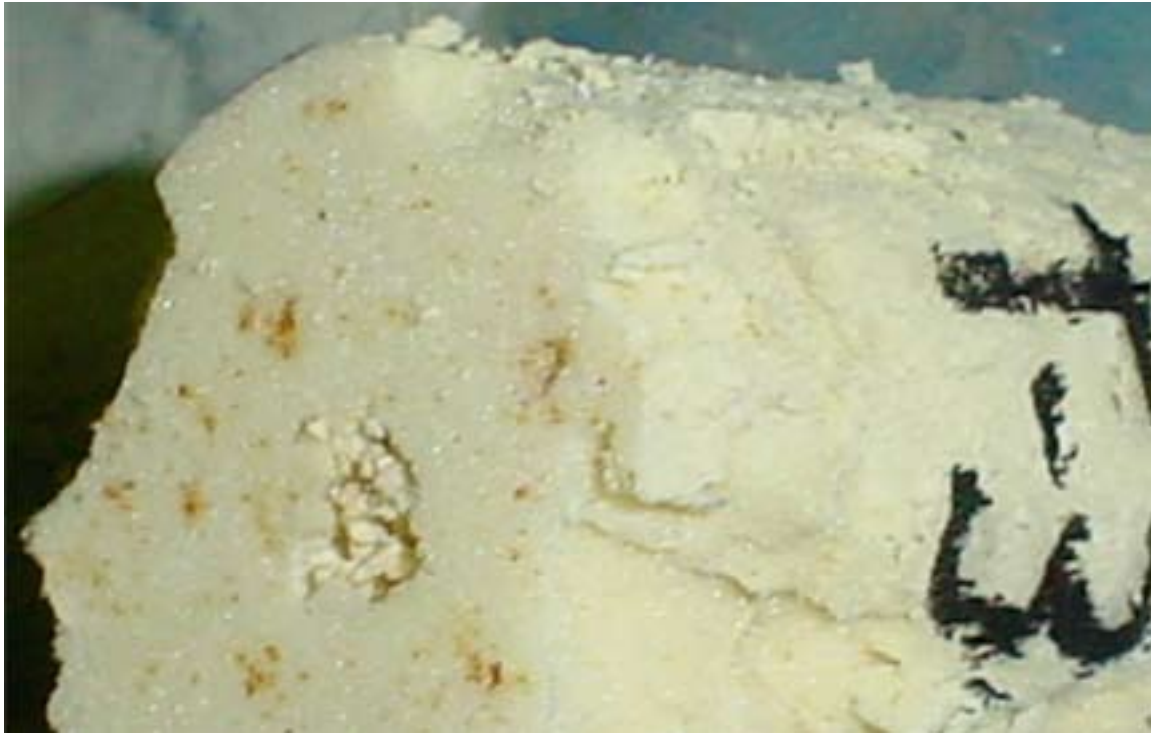
ILLUSTRATION 12: CROSS SECTION VIEW OF TEST CORE SAMPLE 3.
THERE IS NO VISIBLE MATERIAL DEGRADATION NOTED.

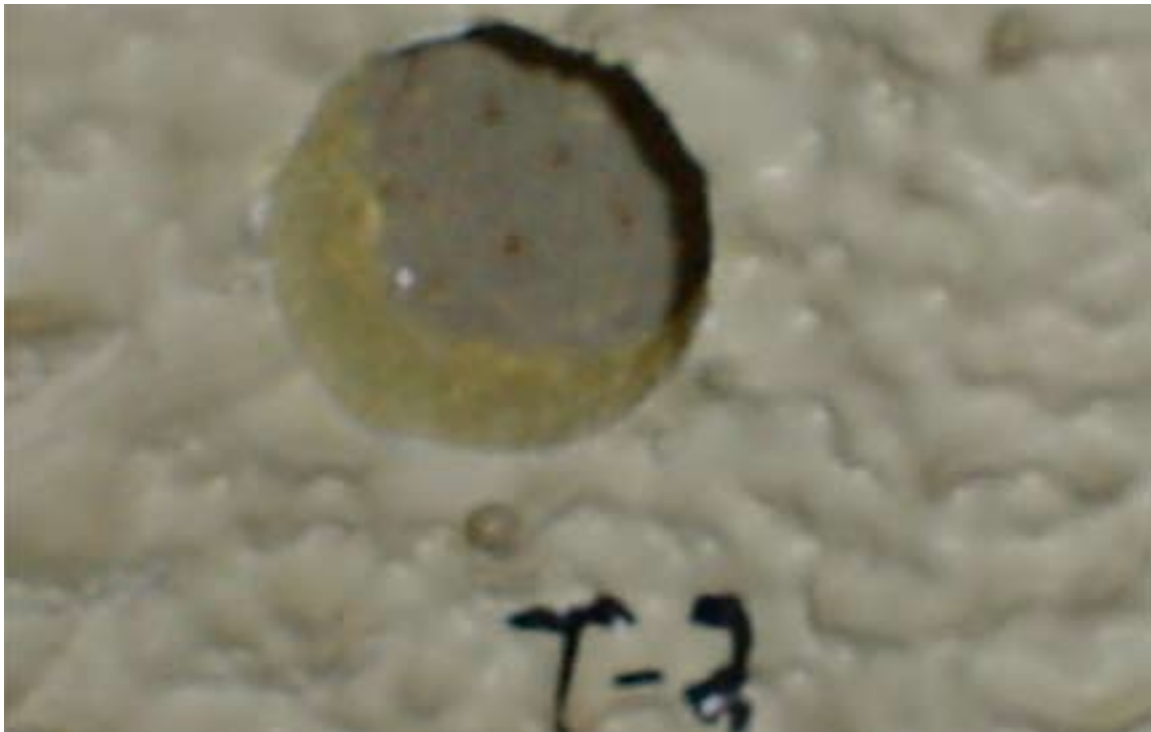
ILLUSTRATION 13: VIEW OF COATING AND STEEL CONDITIONS, TEST AREA 3.
NO MEASURABLE SECTION LOSS NOTED, VERIFIED ULTRASONICALLY.

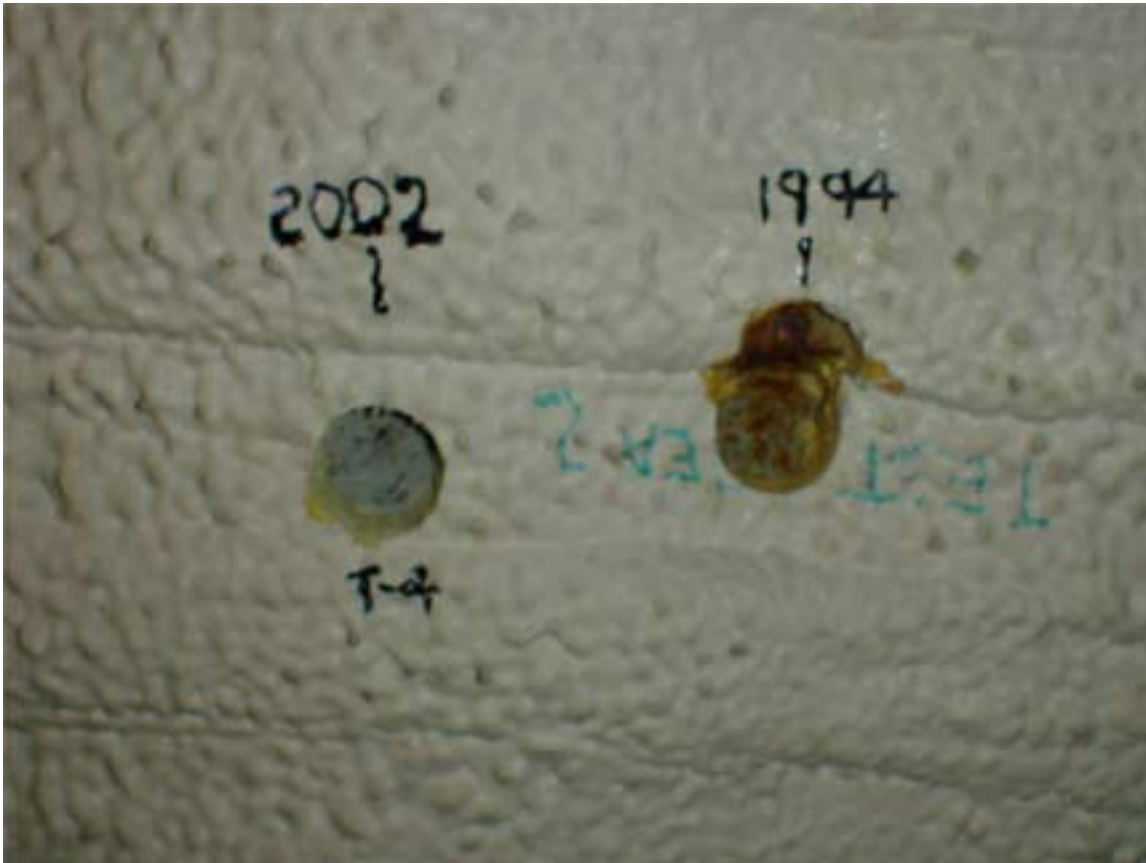
ILLUSTRATION 14: CORE SAMPLE 4 WAS TAKEN IN PROXIMITY TO A 1994 TEST REGION FOR COMPARISON PURPOSES. A SLIGHT INCREASE IN THE NUMBER OF PINPOINT CORROSION CELLS WAS NOTED IN THE 2002 TEST LOCATION. THE EXPOSED TEST LOCATION FROM 1994 HAS DRAMATIC SECTION LOSS IN EXCESS OF 50%. THIS WOULD SUPPORT THE SUPERIOR PERFORMANCE OF THE STAYFLEX™ SYSTEM OVER THE PAST 18 YEARS.

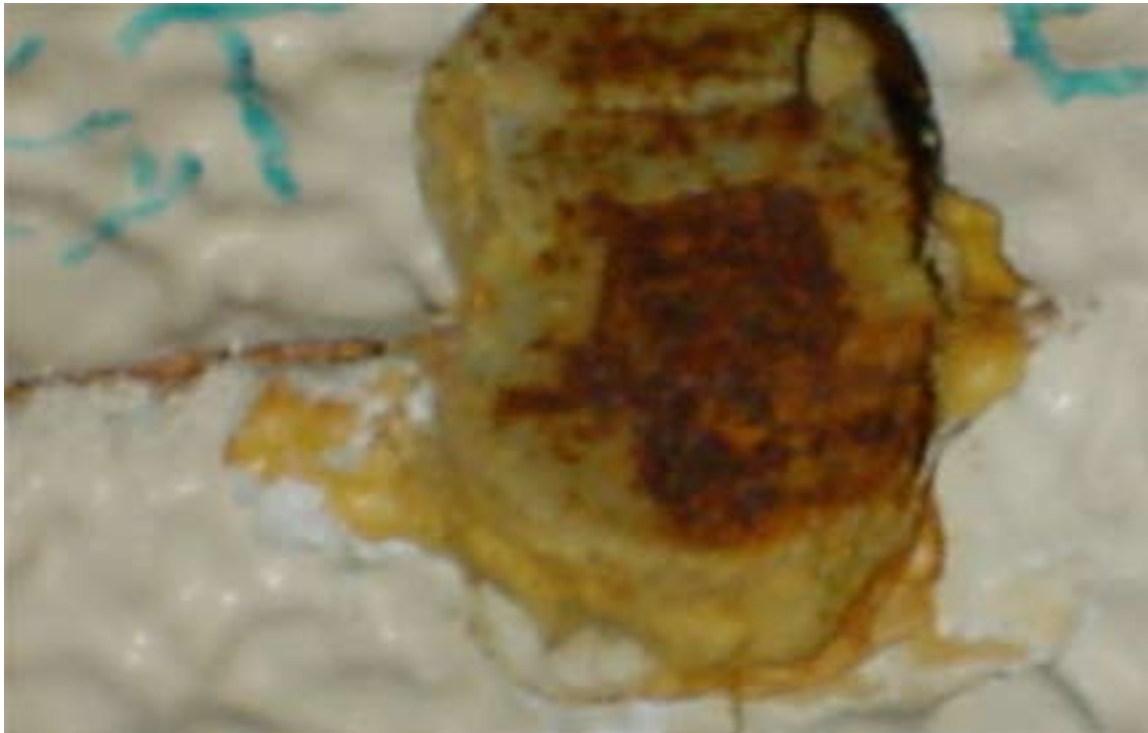
ILLUSTRATION 15: A VIEW OF TEST AREA 2, 1994. SIGNIFICANT DETERIORATION WAS DISCOVERED ON THE UNPROTECTED STEEL ROOF DECKING WHICH HAS BEEN EXPOSED SINCE 1994. THIS DISCOVERY WOULD ALSO SUPPORT THE SUPERIOR PERFORMANCE OF THE STAYFLEX™ SYSTEM IN A HIGH ACID VAPOR ENVIRONMENT.

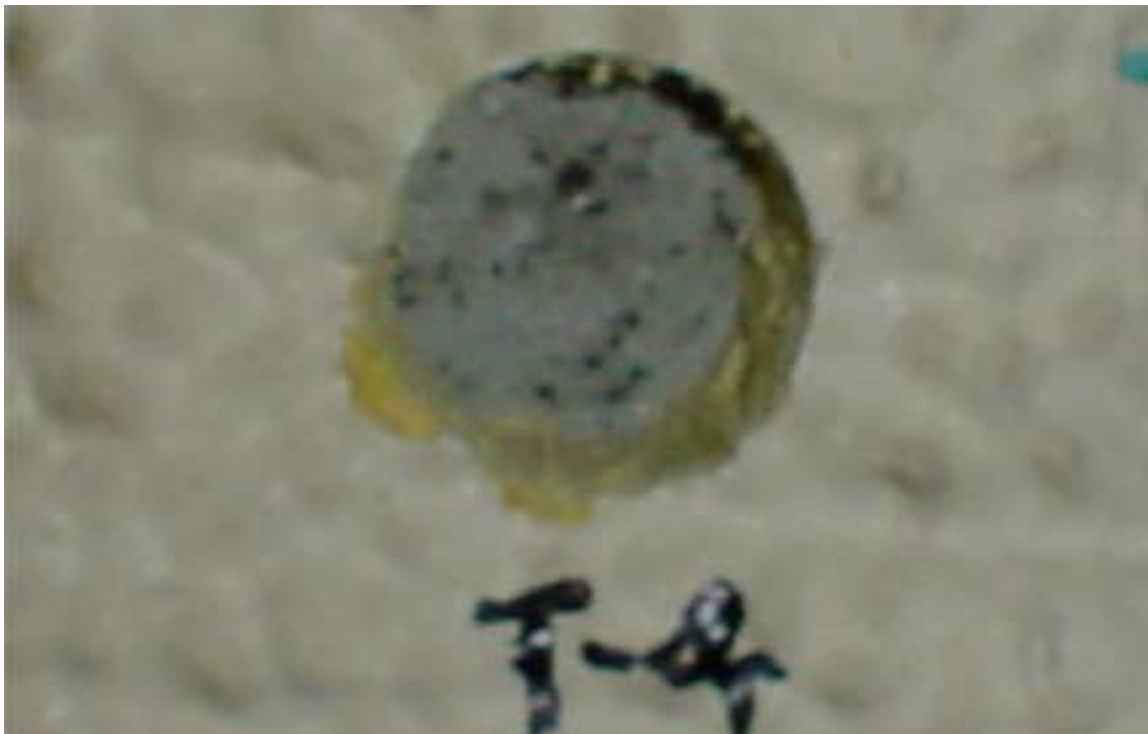
ILLUSTRATION 16: VIEW OF TEST AREA 4. ALL ADHESION CHARACTERISTICS ARE STILL FUNCTIONING. NO MEASURABLE SECTION LOSS INDICATED.

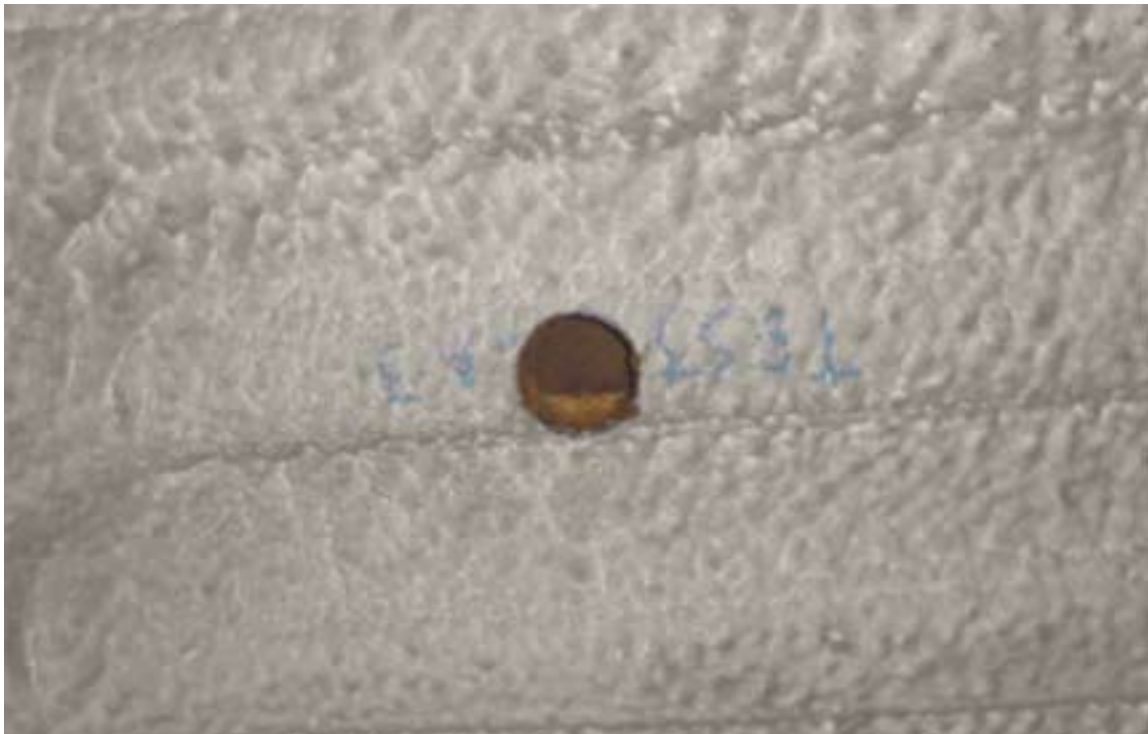
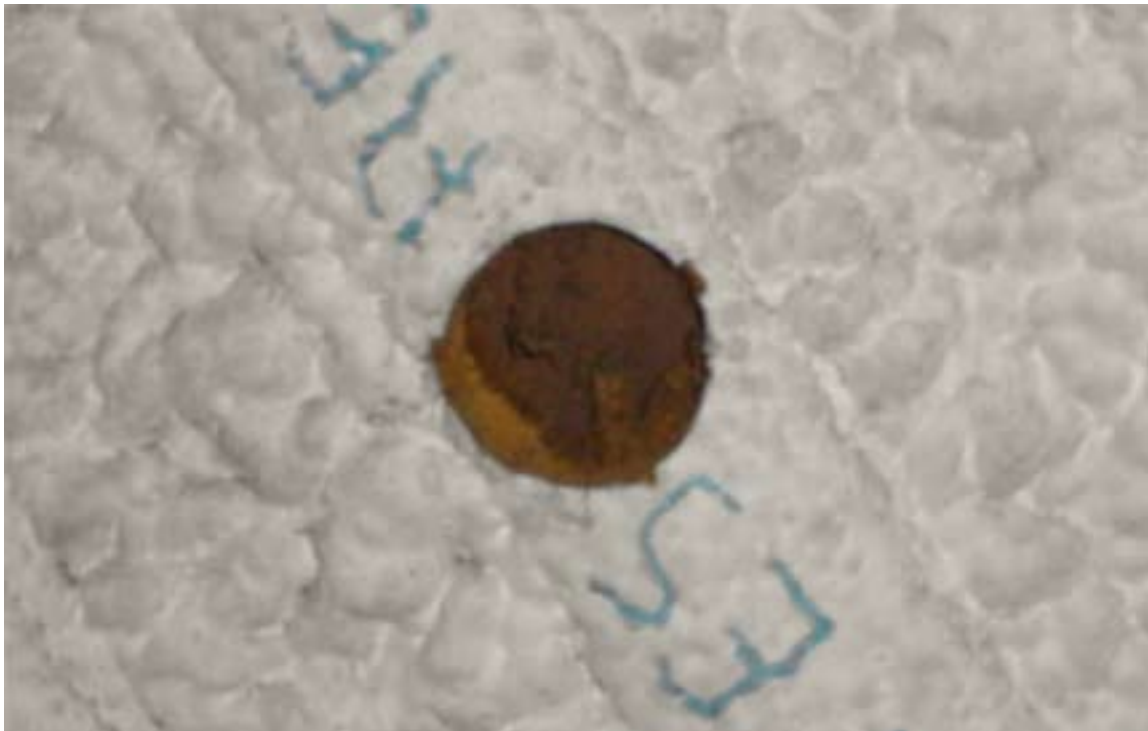
ILLUSTRATIONS 17 & 18: THE DETERIORATED CONDITIONS OF THE ROOF DECKING, EXPOSED SINCE 1994, WOULD GREATLY SUPPORT THE FINANCIAL NECESSITY OF A PRODUCT LIKE THE STAYFLEX™ SYSTEM. FROM 1981 TO 1994, NO MEASURABLE LOSS OF SECTION WAS NOTED ON THE STEEL DECKING, AND ONLY MINOR PIN-POINT CORROSION CELLS. FROM 1994 TO 2002, 100% COATING DETERIORATION HAS OCCURRED, AND SECTION LOSS UP TO 60% WAS DISCOVERED AT THE EXPOSED STEEL TEST POINTS FROM 1994. THIS WOULD SUPPORT TWO POINTS; THAT THE ACIDIC ENVIRONMENT IS EXTREMELY HOSTILE, AND THAT THE STAYFLEX™ SYSTEM IS PROVIDING EXCELLENT PROTECTION FOR THE ROOF STEEL.
